# Empirical modelling of run-up and overtopping at a boulder beach, Raglan, New Zealand

Tom D. Shand<sup>1</sup>, Richard A. Reinen-Hamill<sup>1</sup>, Roger D. Shand<sup>2</sup> and Wouter Viljoen<sup>3</sup>

<sup>1</sup>Tonkin & Taylor Ltd. Auckland, NZ. [tshand@tonkin.co.nz](mailto:tshand@tonkin.co.nz), [rreinenhamill@tonkin.co.nz](mailto:rreinenhamill@tonkin.co.nz)

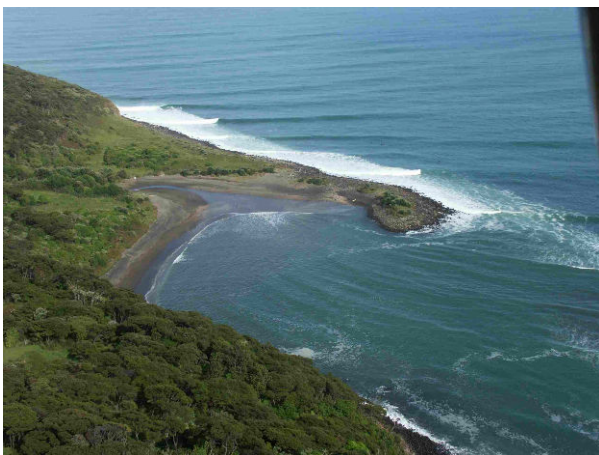
Figure 1 Boulder bank at Whale Bay, Raglan (Source: Skyworks Waikato, 2005).

The barrier spit is comprised of boulders ranging from 300mm to over 1 m in diameter. The intertidal seaward face of the barrier spit has slopes between 5(H):1(V) and 7(H):1(V). This is a fairly typical slope for materials of this size. The slope then decreases to near horizontal on a berm located at around the low tide mark before steepening again to around 10(H):1(V) to 15(H):1(V). This slope continues fairly consistently offshore. The backshore region is near horizontal and heavily vegetated with shrubs and grasses.

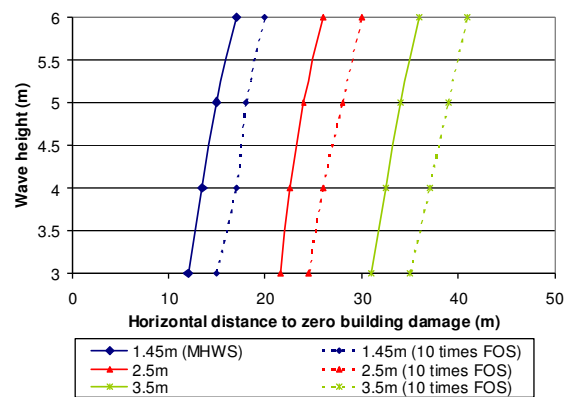
For a building to suffer no damage during an overtopping event, a tolerable mean discharge rate has been determined through empirical studies (HR Wallingford Ltd, 1999). This tolerable mean discharge rate is given at  $0.000001\text{m}^3/\text{s}/\text{m}$  or  $0.001\text{ l/s/m}$ . A summary of these distances is presented in Table 3 and Figure 4.

Figure 4 Horizontal distance from crest to achieve mean tolerable discharge corresponding to zero building damage for a range of water level scenarios.

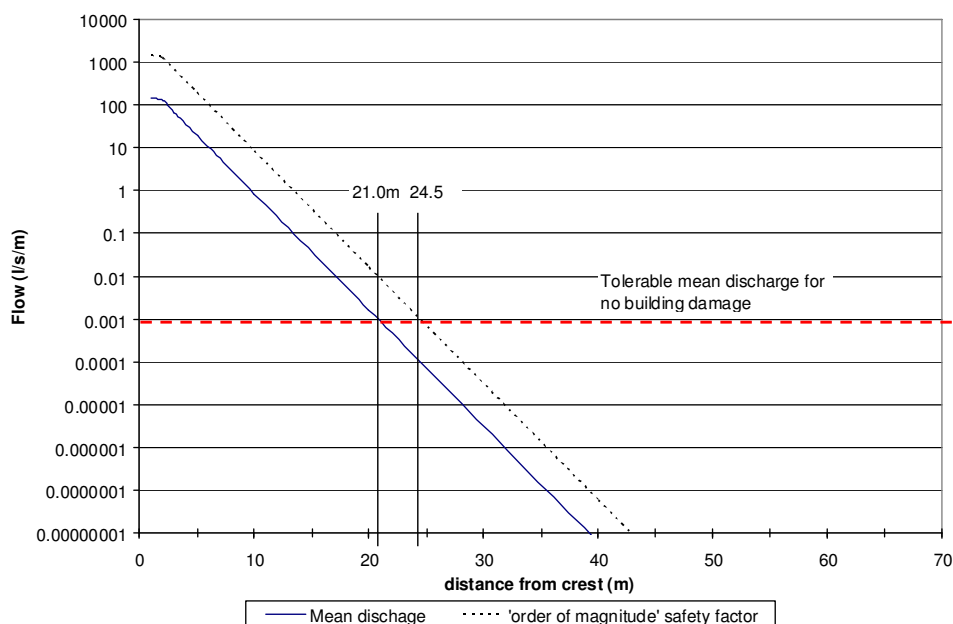
For the case of still water level of 2.3m above MSL and significant wave height of 4.1 m, which corresponds roughly to the September 2005 event, a mean overtopping discharge at the crest of  $144\text{ l/s/m}$  was obtained. This corresponds to a zero building damage distance of 21.0 m unfactored and 24.5 m factored from the beach crest (refer Figure 5).

Figure 5 Mean overtopping discharge calculated for the September 2005 storm event

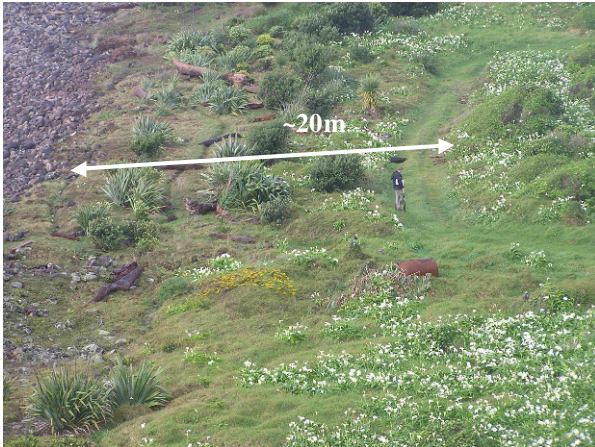
These values agree reasonably with the observed distance that material was transported by overtopping during the storm event as described by Eco Nomos, 2005 (refer Figure 6).

Figure 6 Distance from crest to over-wash debris from the September 2005 storm event. Photo: Eco Nomos Ltd

Observation at the site following the September 2005 event suggested that reasonably significant overtopping occurred, with debris being transported up to 15 to 20 m back from the crest (Eco Nomos, 2005). While the landward extent of flooding cannot be determined using the above run-up model, an overtopping height of 0.7 m appears to better fit the site observation. This will be further discussed in the overtopping assessment (refer Section 4.3).
